CONTROL AND BLOCK BRICK SYSTEM

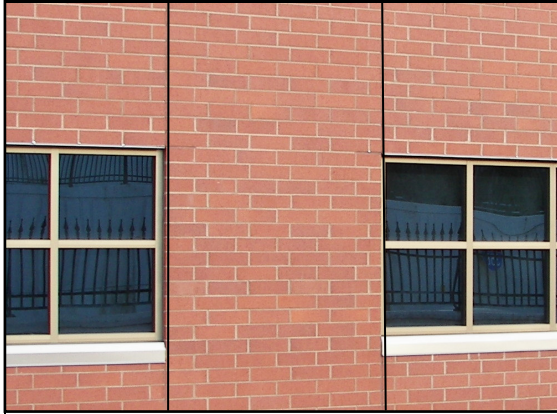
Problem: Joint and windows in line with each other.

With the expansion and contraction of the brick that occurs naturally due to the temperature changes, the masonry joint or brick will crack beyond the lintel beam causing building weakness and leaking around the joint and window.

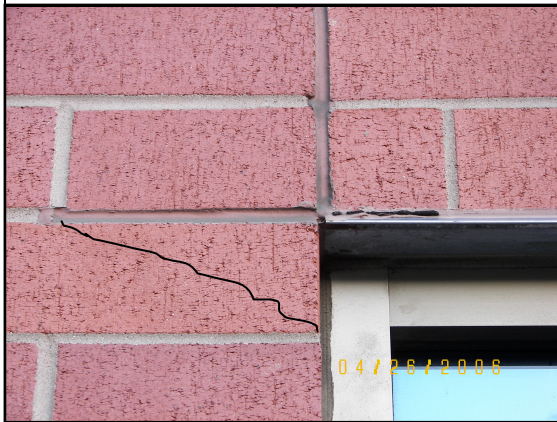
Shows a split on the head of the brick lintel movement. Crack in brick.

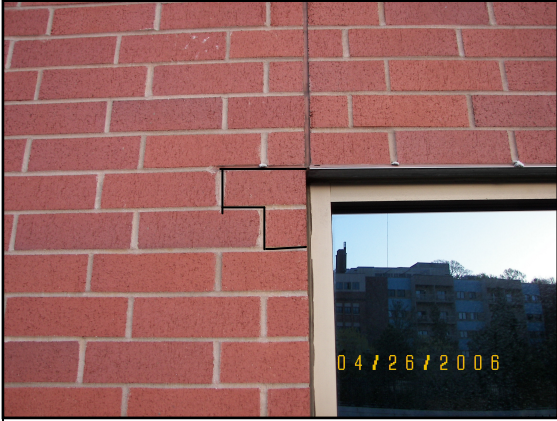
Joint at window. Brick lintel going 4” beyond the window. Crack in joint.

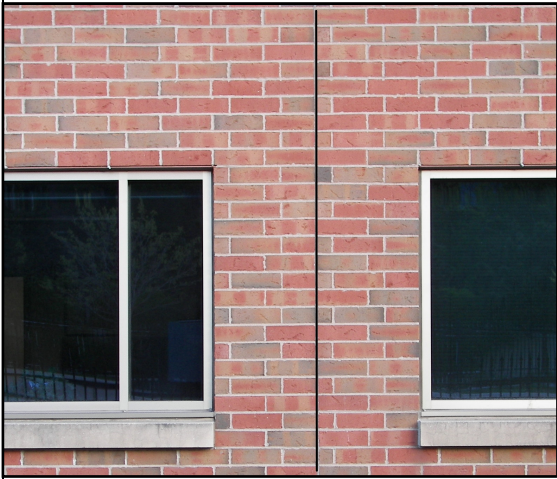
Solution: Keep the expansion/control joint past the window support (lintel). This gives the building system the ability to work correctly by letting the joints move freely from the steel lintel.

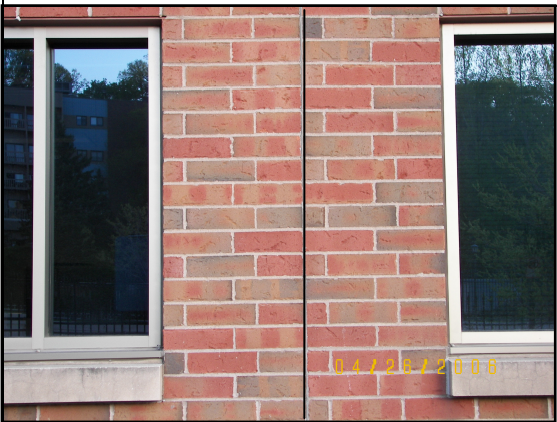
Window with control joint past the window support.
